NGT_AH2_08 St Fergus Cabs Asbestos Mitigation

Engineering Justification Paper

June 2023

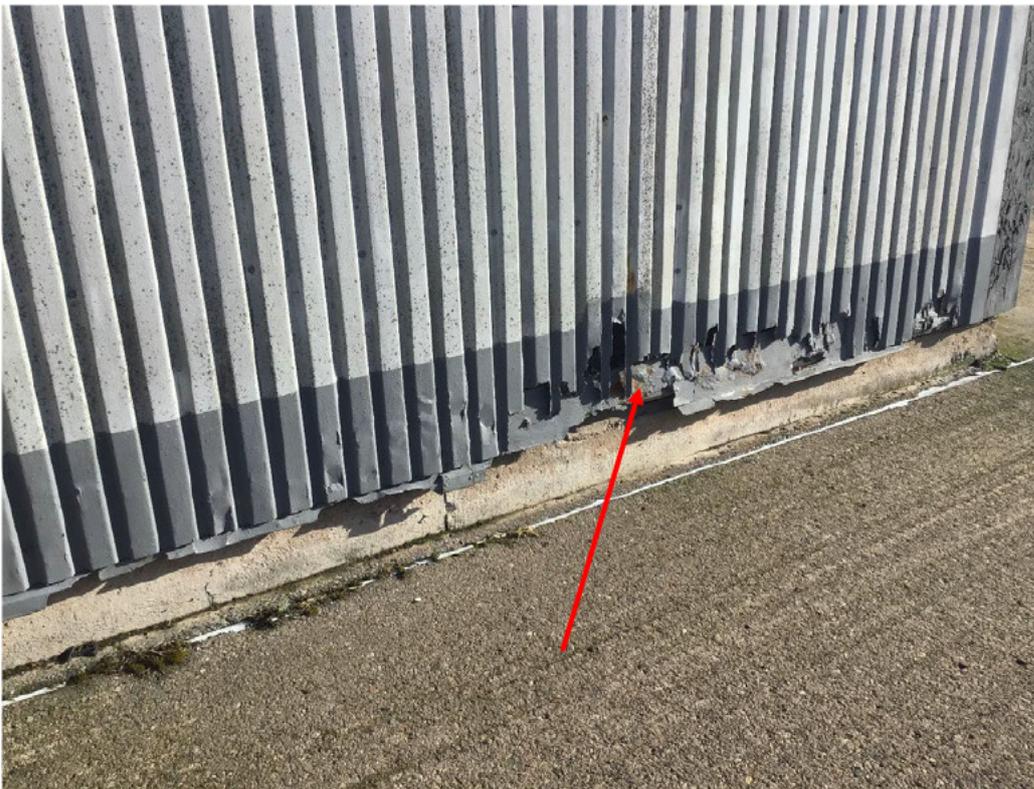
34. Remedial work to be done on each Unit or lack of it will be determined in section 8 after considering all the possible options.
35. The following pictures highlights the status of the cladding on units covered in this paper. Figure 4 and Figure 5 show the nature of damage that has already occurred on Unit 1C, which is the worst affected. This has left the lower part of the cladding badly damaged and in need of repair or replacement. The other Units are already showing signs of flaking and peeling as presented below.

Figure 4: Damage on 1C Bottom Cladding

55. The assessments outlined in this paper and the associated discounting demonstrates that the most cost effective and logical option is to paint and encapsulate asbestos cladding on Units 1A, 1B and 1D, whilst Unit 1C is recommended for decommissioning.

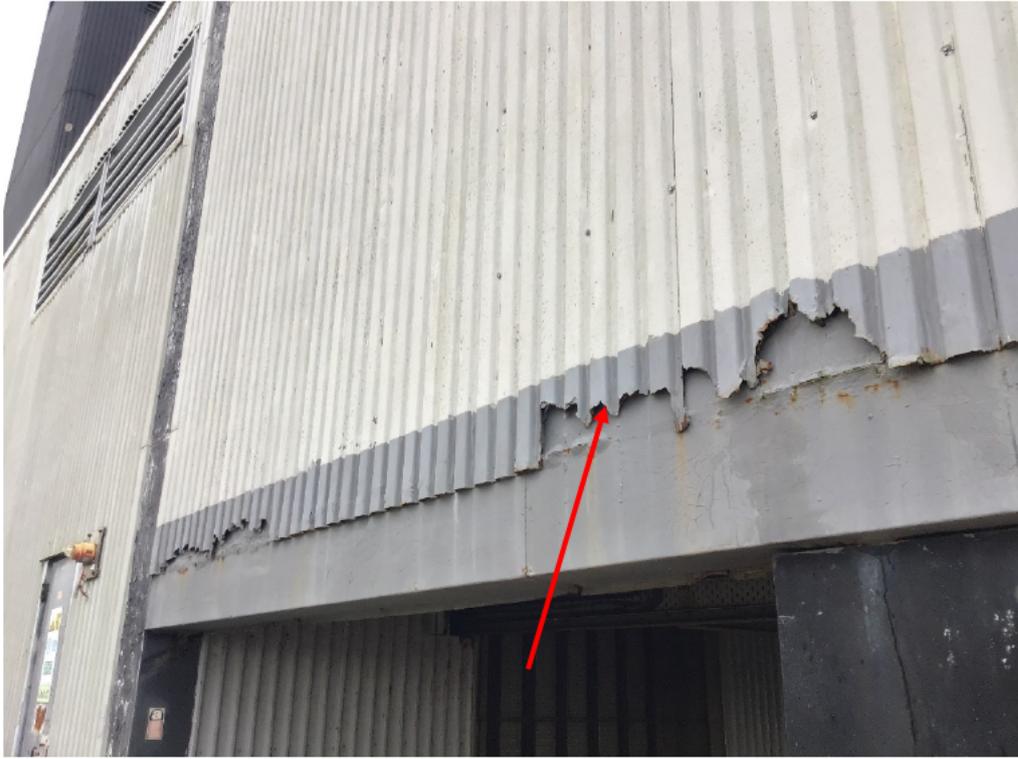
Figure 5: Flaking Cladding on 1C

40. It is of paramount importance to note that Units 2C and 2D, which are currently due for decommissioning as justified in a different paper, had badly damaged cladding. The same phenomena which these two Units exhibited is what has started to manifest on Unit 1C which is covered in this paper as shown on Figure 5.

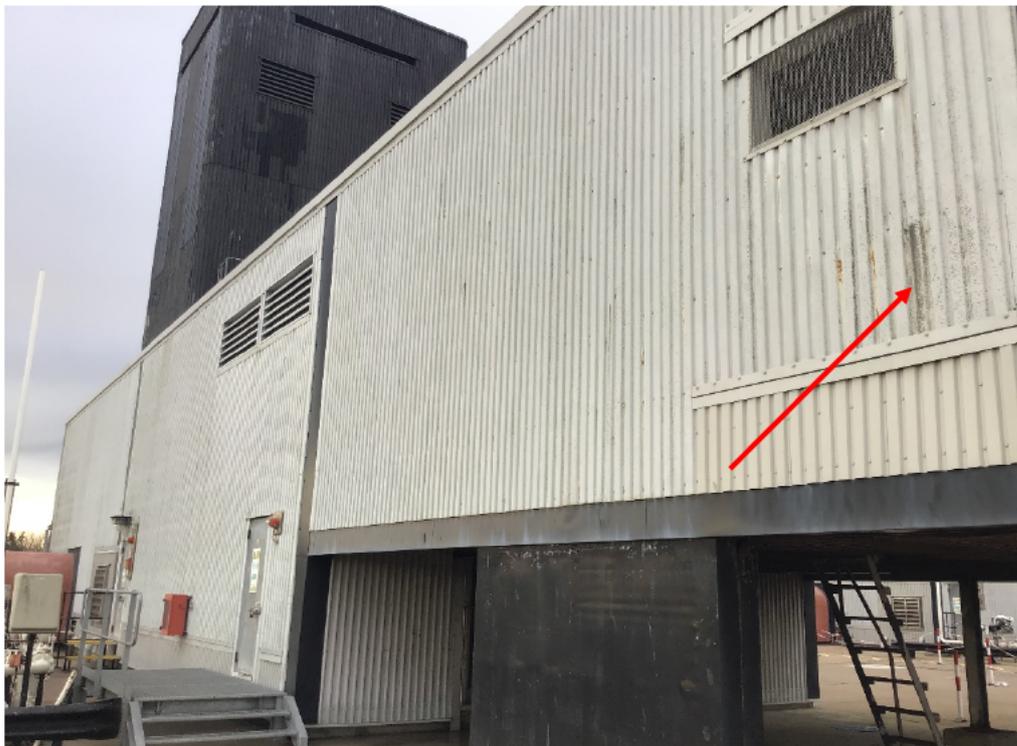
36. Figure 6, Figure 7 and Figure 8 show the extent of damage or flaking on Units 1A, 1B and 1D respectively. It is clear that these Units are in a better state as compared to Unit 1C. However, evidence of flaking which exposes asbestos fibre has already started to occur as marked on each of the pictures and there is therefore a need to mitigate the risk.

Figure 6: Flaking Cladding on 1A

- Removal of damaged and flaking paint / bitumen to Galbestos sheeting to cabs 1A, 1B and 1D.
- On completion of the removal of these areas the Galbestos will be encapsulated with two coats of ET-150 using either hand brushes or paint sprayers.
- A localised environmental clean will be conducted to the floor level of the building perimeter
- Works to be conducted under controlled conditions.
- Statutory air monitoring is to be provided as part of this work scope
- Allowance to remove all waste generated as part of the contracted works

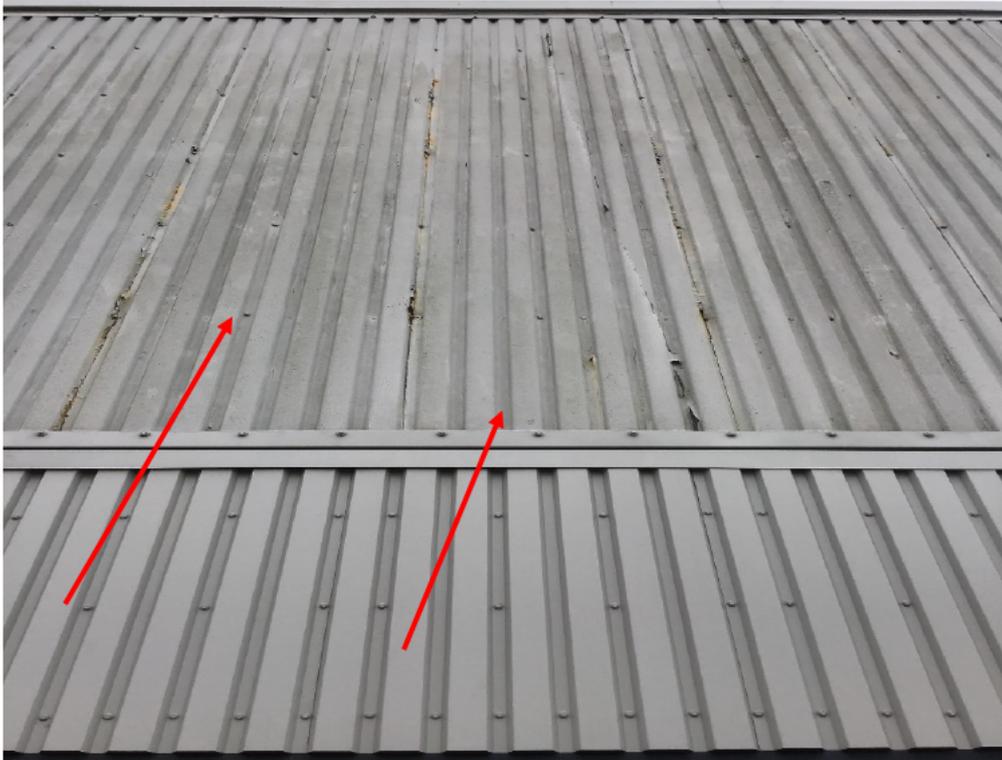
Figure 7: Flaking Cladding on 1B

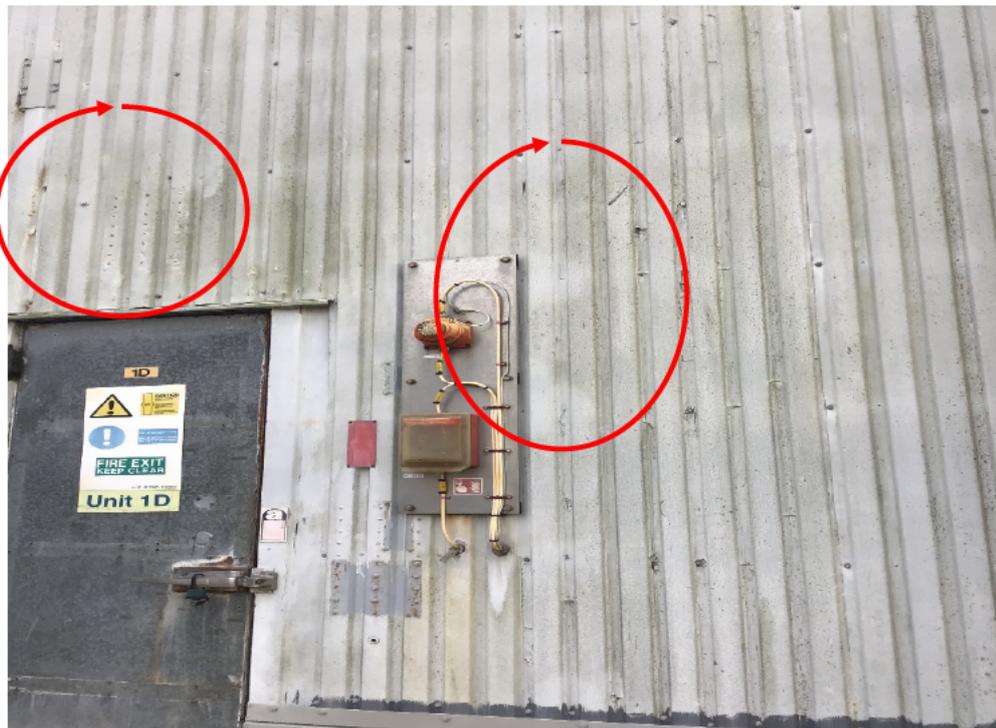
Figure 8: Flaking Cladding on 1D
