NGT_AH2_03

St Fergus

HV Transformers

Engineering Justification Paper

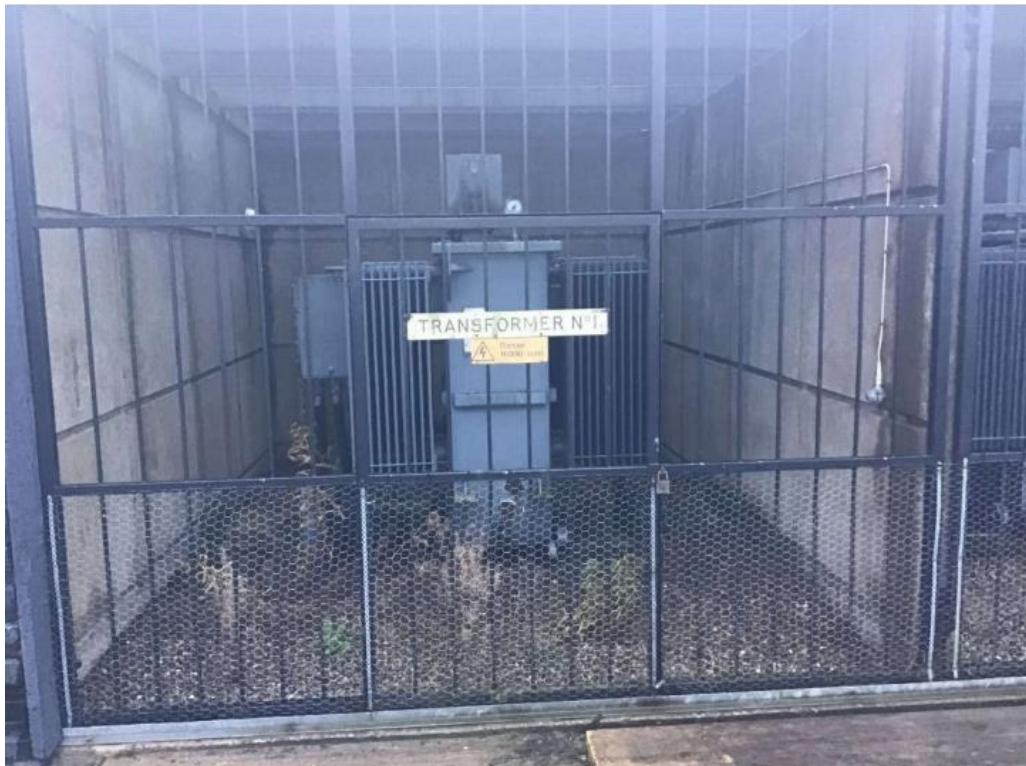
62. Currently BGC/T1, P1/T1 and P2/T1 have been isolated from plant operating service. P1/T1 oil was drained after severe corrosion on the transformer body caused an oil leak in 2020. This transformer was inspected and deemed damaged beyond repair as the internal components of the transformers were also severely corroded.

Figure 7 Plant 1 T1 transformer 1 currently isolated

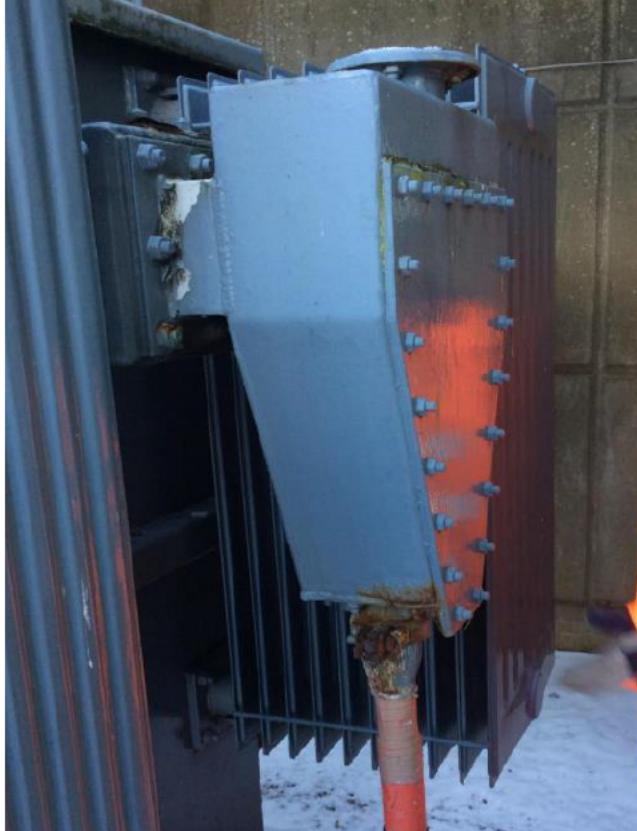
64. All remaining transformers are also in severely bad condition where corrosion and leakage can be identified on the tank and radiator fins. Paintwork on the transformers is very rusty and flaking off as seen in figure 8 and 9.
65. The visual inspection concluded that where the HV cables have been exposed to the environment, the cable insulation sheath is showing deterioration and cable glands were showing corrosion.

Figure 8 Corrosion on the radiator fins and connecting cables

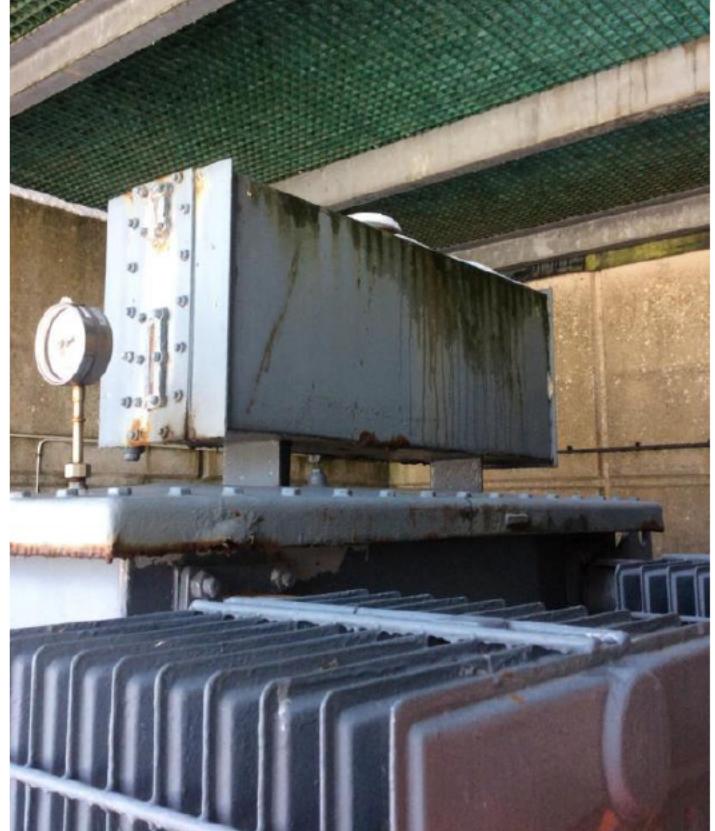
Figure 9 Leaking oil from conservator tank and corrosion
