St Fergus Compressor Emissions Re- opener: Asset Health Distribution Boards

Engineering Justification Paper

December 2025

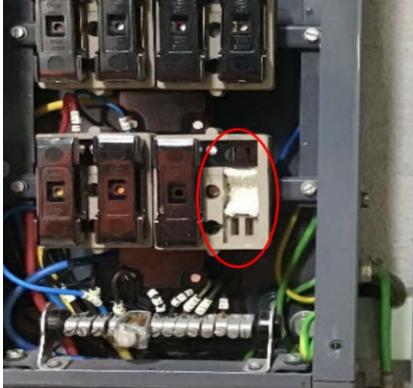
5.1.6 Figure 3 and Figure 4 illustrate examples of boards and exposed fuse holder sections (red circles) that contained asbestos in fuse holders. Fuses were consumables that require periodic replacement, exposing maintenance personnel to asbestos fibres during routine work, an unacceptable risk under health and safety regulations as per the Control of Asbestos Regulation 2012. The exposed fuse holder sections (red circle) of the below DBs contained asbestos material which poses a major occupational health risk mainly to maintenance personnel.

Figure 2: Asbestos presence on DBs BD(L)	Figure 3: Asbestos presence on Fuse board 'G' SB/3-E415V 1	Figure 4: Services DB1 exposed terminations

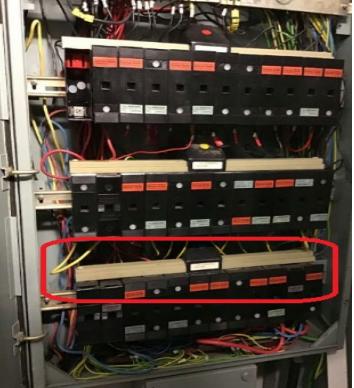
5.1.7 Some boards also lacked Ingress Protection (IP2X), leaving live parts such as bus bars exposed, as shown in Figure 5. This creates a severe electrical safety hazard for personnel and equipment.

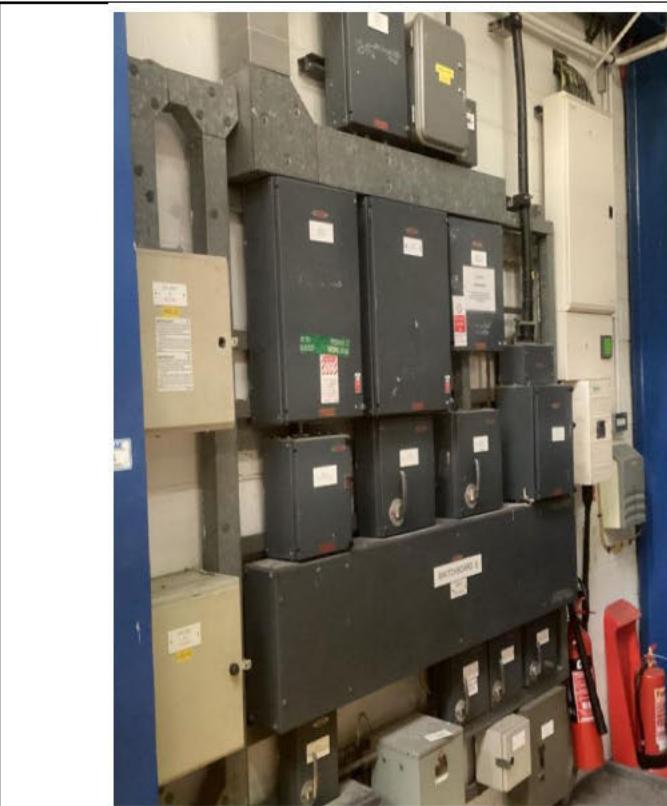
Figure 5: Pre-replacement: DB H, DB E, DB F, DB G and Switchboard 3

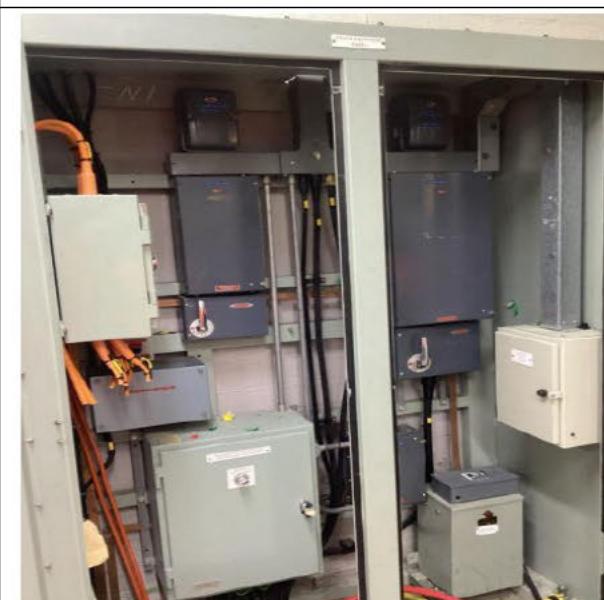
Figure 7: Pre-replacement: DB LV, DB L, DB P

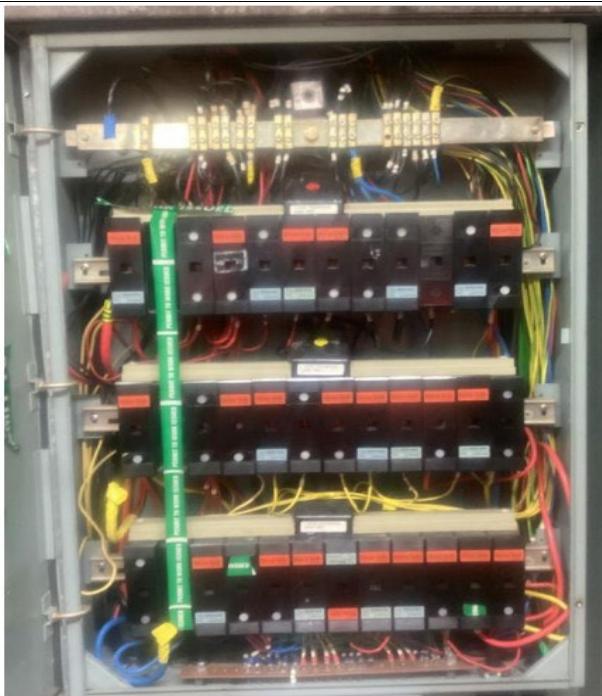
Figure 9:Pre-replacement: DB 1

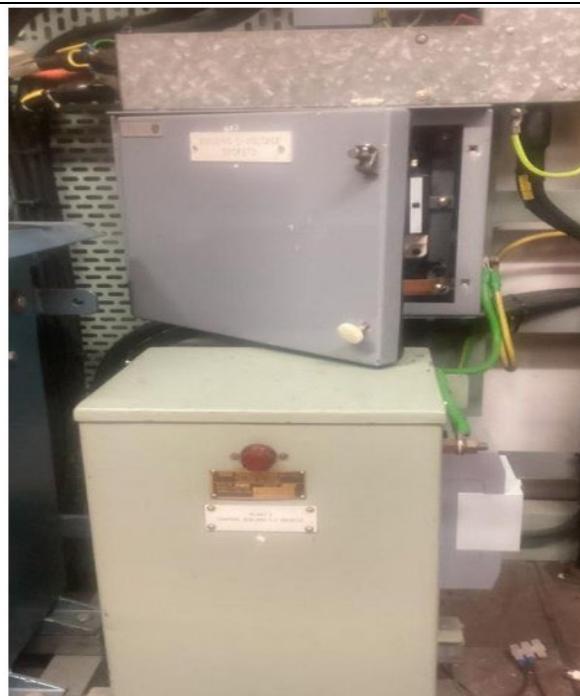
Figure 11:Pre-replacement: DB 3

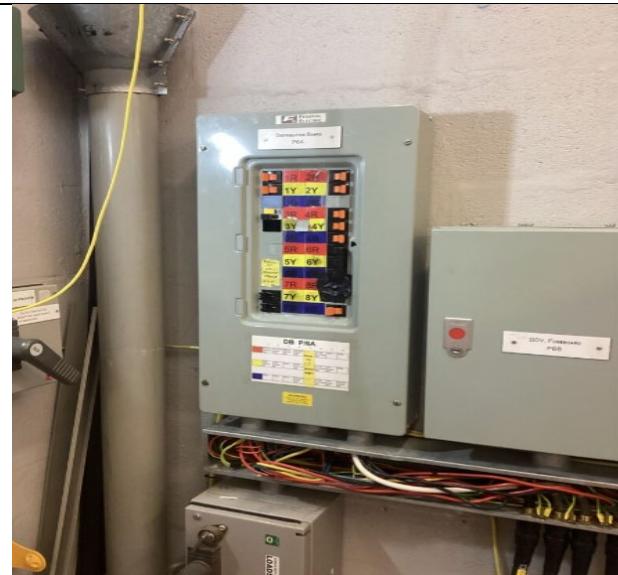
Figure 13:Pre-replacement: DB P6A

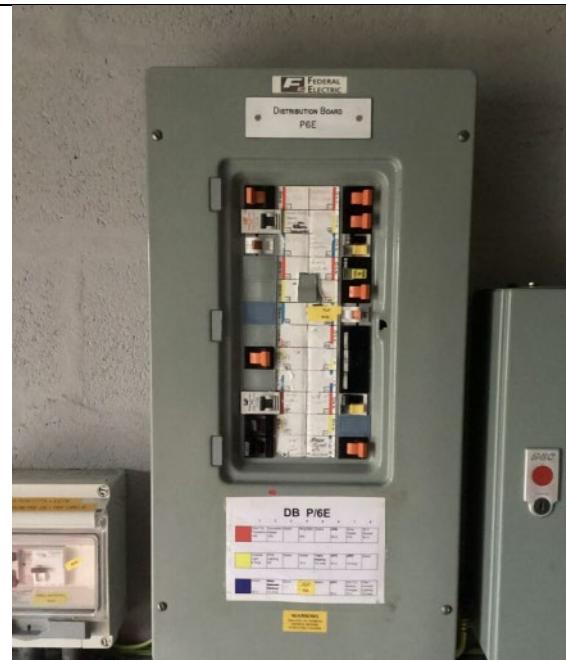
Pre-replacement: DB P6E

Post-replacement: DB P6E- Installation ongoing
