HYNTS CORROSION

# Summary Report

National Gas Transmission plc

**Report no.:** 10581430-4, Rev. 1

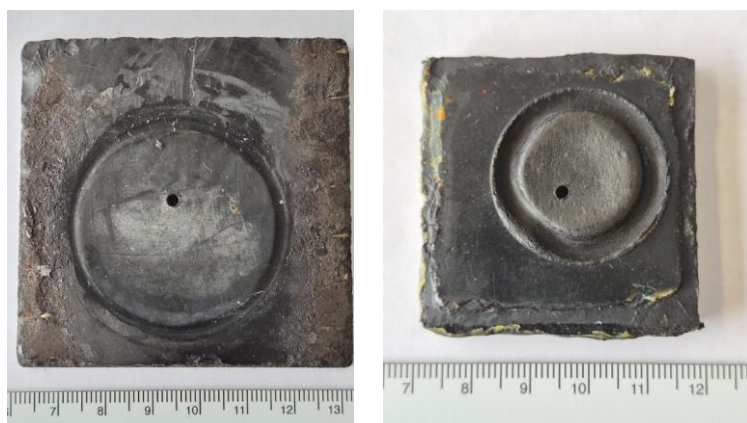
**Figure 7 - CALT Top view of samples after exposure to NS4 at room temperature. Left, CALT control sample. Right, CALT sample charged with hydrogen.**

Figure 7 shows the top view of CALT samples after exposure in NS4 under none and hydrogen charging conditions. Both samples exhibited deformation around the O-ring used to seal cells and avoid leaks. No corrosion products are observed in the artificial defect. At room temperature, CALT coatings exhibit noticeable deformation due to the viscoelastic nature of their adhesive layer. The relatively soft adhesive readily conforms to the curved geometry of the O-ring, leading to localized compression, indentation, and lateral flow of the adhesive material under sustained contact pressure. Even without elevated temperature, time-dependent creep could occur, causing the coating to progressively mold around the O-ring and reduce local thickness at the point of contact. This deformation is largely non-elastic, leading to a limited recovery once the load is removed, and it reflects the design of CALT coatings and the intention to accommodate surface irregularities. However, such localized deformation can also influence interfacial stress distribution and may create preferential pathways for fluid ingress if the pressure is maintained for extended periods.

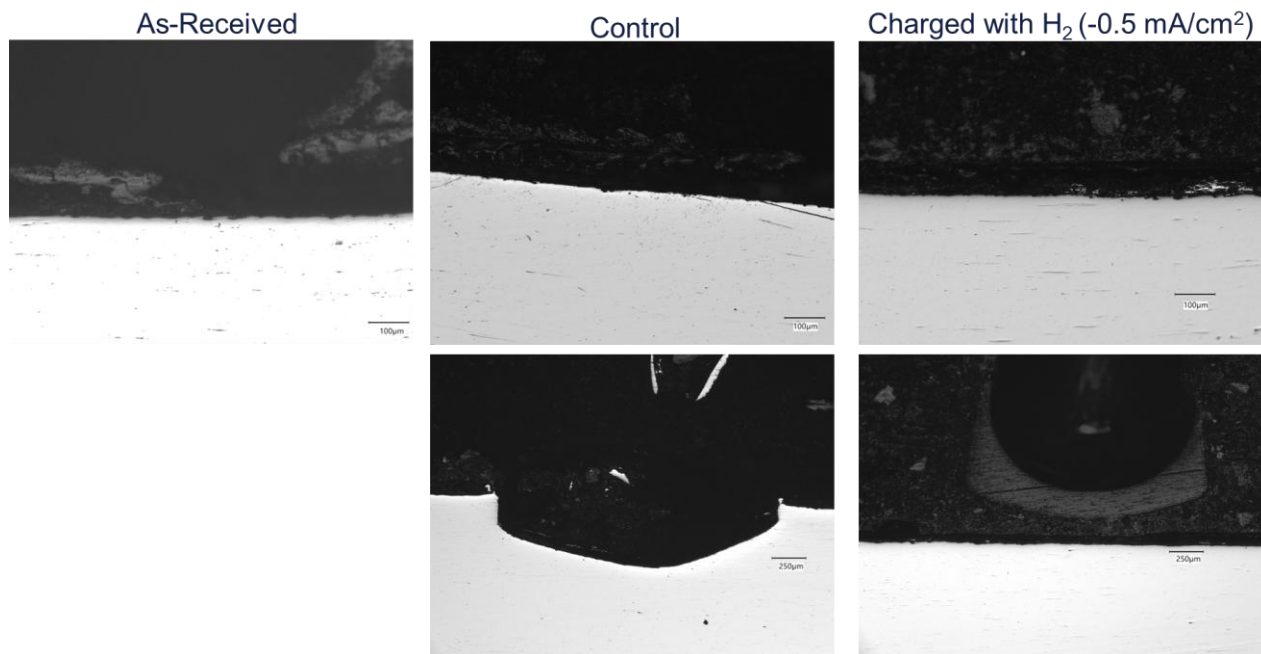
**Figure 8 – Cross section of CALT samples.**

Figure 8 presents cross-sectional optical micrographs of CALT coating in the as-received, control (exposed, uncharged), and electrochemically charged with hydrogen at  $-0.5 \text{ mA/cm}^2$  conditions. The top row shows the general coating–substrate interface, while the bottom row highlights the response of the coating around the artificial defect. In the as-received condition, the CALT coating exhibits a continuous, well-adhered structure. The laminate backing remains intact, and the adhesive layer shows intimate contact with the steel substrate without visible gaps or interfacial defects. The control sample, which was exposed to NS4 solution but not hydrogen charged, shows no significant changes relative to the as-received coating. The coating steel interface remains continuous, and there is no evidence of interfacial debonding or cracking. The lower control image shows deformation around the defect, likely a result from drilling the hole. The coating has flowed and conformed to the imposed geometry rather than cracking or delaminating, demonstrating the inherently viscoelastic and ductile response of the CALT adhesive and backing under compressive loading. The sample charged with hydrogen at  $-0.5 \text{ mA/cm}^2$  shows that the coating remains adhered to the steel and no gross interfacial disbondment is observed, subtle changes can be seen at the adhesive region and within the coating body around the defect. Overall, no significant changes are observed that could be related to damage due to interaction of CALT with hydrogen.

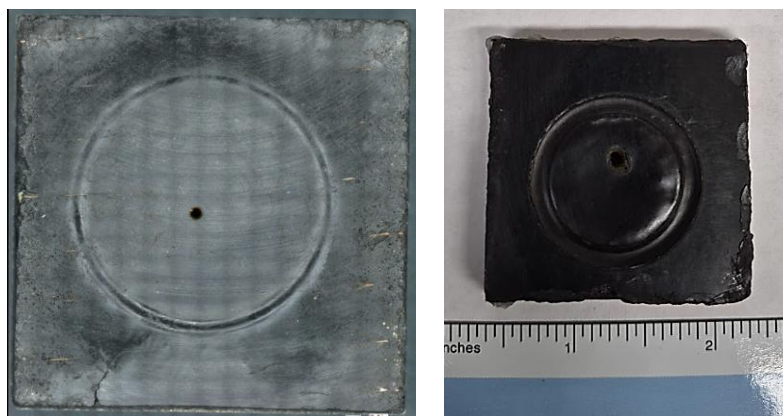
**Figure 10 – CTE Top view of samples after exposure to NS4 at room temperature. Left, CTE control sample. Right, CTE sample charged with hydrogen.**

Figure 10 shows the top view images of CTE control and hydrogen charged samples. Both samples exhibit deformation around the O-ring area. No corrosion products are evident around the artificial defect. The deformation is further promoted by the low modulus and low hardness inherent to coal tar enamel, especially at room temperature or slightly elevated temperatures. Under compression, stresses are concentrated along the narrow contact line of the O-ring. In CTE coatings, these stresses can exceed the yield resistance of the bituminous phase, causing the coating to displace laterally. This behavior contrasts with more rigid epoxy or polyurethane coatings, which can better resist localized compressive loading without significant shape change.

Environmental exposure also plays an important role in the electrochemical response of these samples. CTE readily absorbs water and organic constituents from soil or electrolyte environments, which plasticizes the bitumen matrix. Water uptake reduces intermolecular cohesion within the coal tar phase, lowering stiffness and increasing susceptibility to deformation under mechanical load. If the O-ring compression occurs after electrolyte exposure, the coating is more prone to indentation and flow.

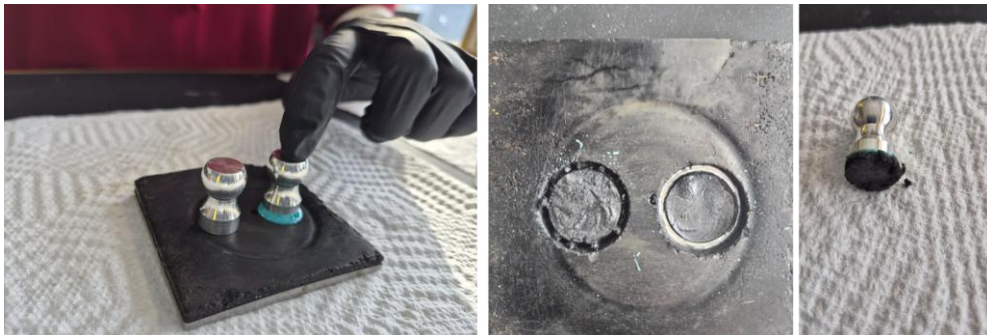
**Figure 11 – CTE Pull off test assembly and results.**

After visual inspection, the samples were subjected to pull off tests. As seen in Figure 11, the pull off test was not compatible with CTE. When tensile stress is applied through a pull off dolly, the coating does not store elastic strain energy and fracture cleanly. Instead, it undergoes plastic flow and creep, redistributing the applied stress over time. As a result, the coating may elongate, neck, or deform extensively without producing a distinct failure event. The test often indicates low apparent “adhesion” values that reflect material yielding, not true loss of adhesion to the steel substrate. Another critical limitation is the low cohesive strength of CTE relative to the stresses imposed by pull-off testing. Even when adhesion to steel is adequate, the tensile load concentrates within the bulk of the coating beneath the dolly. This

commonly results in cohesive tearing, smearing, or cold flow of the enamel rather than a sharp cohesive fracture or interfacial separation. Because the failure mode is dominated by viscous deformation, the measured pull off strength is neither reproducible nor representative of coating performance. Additionally, in CTE systems, the adhesive bond is often stronger than the enamel itself, causing deformation or failure within the coating during glue curing or alignment.

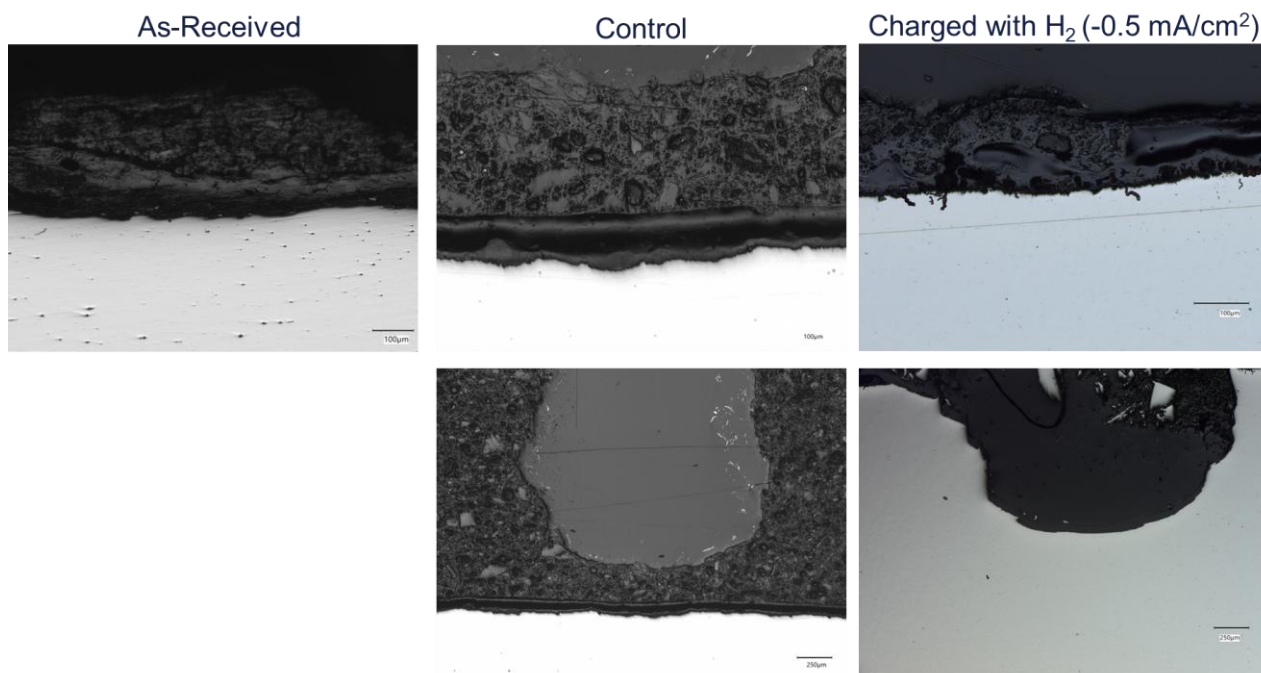
**Figure 12 – Cross section of CTE samples.**

Figure 12 contains the cross-sectional optical micrographs of a CTE coating under as-received, a control exposure, and electrochemically charged with hydrogen. In the as-received condition, the CTE coating exhibits the characteristic layered and highly heterogeneous structure typical of coal tar-based materials. The coating appears relatively thick and dark, with visible inclusions and filler-rich regions embedded within the bituminous matrix. The interface between the coating and the substrate is continuous and well defined, with no obvious large-scale separation or void formation. This microstructure is representative of a thermoplastic, viscoelastic material that has been applied hot and subsequently cooled, resulting in internal textural features but overall good adhesion in the unexposed state.

The control sample, which was exposed to NS4 without hydrogen charging, shows no significant differences when compared to the as-received condition. Localized deformation is evident near the artificial defect, and this is consistent with viscoelastic creep under contact or constraint.

In contrast, in the hydrogen-charged sample, the CTE layer appears to have flowed extensively, forming smooth, rounded profiles and with local thinning or detachment from its original geometry. This might be a result of the compression to which the sample was subjected during testing. Overall, no significant differences are observed when compared to the as-received and control samples.

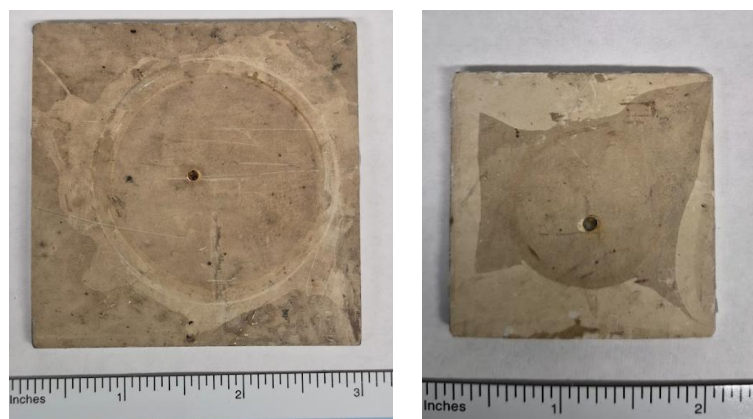
**Figure 14 – FBE Top view of samples after exposure to NS4 at room temperature. Left, FBE control sample. Right, FBE sample charged with hydrogen.**

Figure 14 shows the top view of the control and hydrogen charged FBE samples. Both samples show signs of discoloration and corrosion product in the defect. No signs of blister or delamination are observed. Discoloration of the FBE coating is primarily associated with water uptake, chemical exposure, and pigment or filler degradation within the coating system. FBE coatings are inherently hygroscopic, and exposure to soil solutions or simulated soil electrolytes promotes moisture absorption into the epoxy matrix, leading to plasticization and changes in the local refractive index that manifest as lightening, cloudiness, or non-uniform color variation. Water ingress also facilitates chemical interactions between the coating and environmental species such as chlorides, sulfates, or locally acidic or alkaline constituents, resulting in chemical modification of the epoxy network. Additionally, pigments and fillers within the FBE, such as titanium dioxide or iron-based compounds, are susceptible to interaction with moisture and electrolytes, leading to oxidation, leaching, or migration.

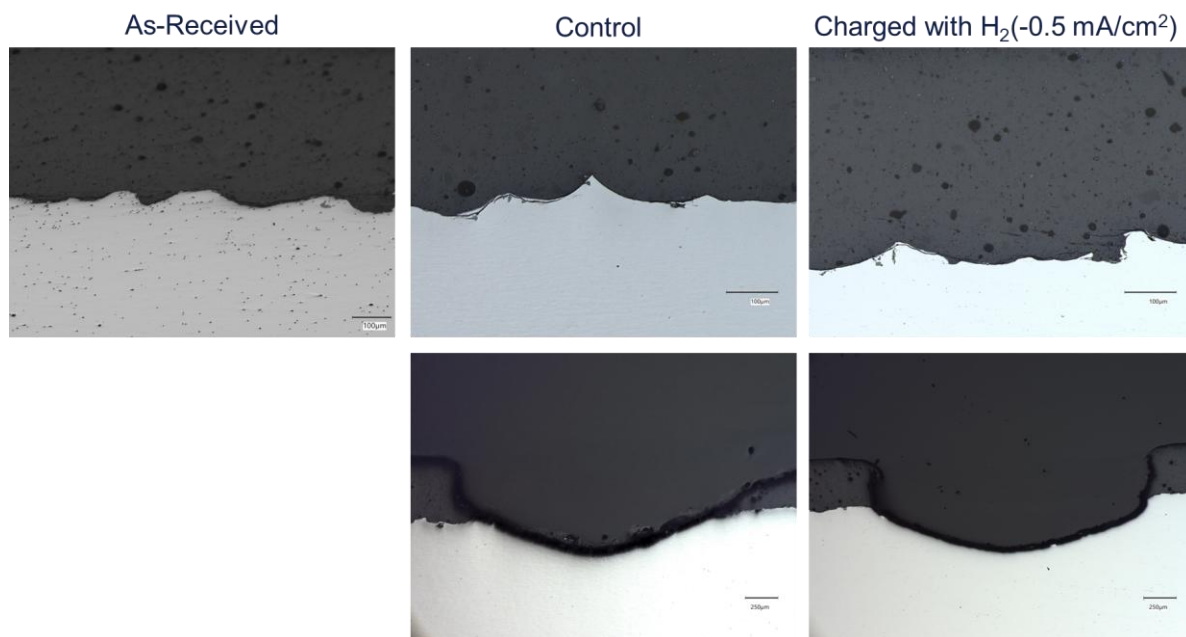
**Figure 15 – Cross section of FBE samples.**

Figure 15 compares cross-sectional micrographs of FBE-coated steel in the as-received condition, after exposure of the coating side to NS4 soil-simulating solution (control), and after combined NS4 exposure and hydrogen charging. In the as-received state, the FBE coating is uniform and well adhered to the steel, with a smooth and continuous interface. Following NS4 exposure alone, the control sample shows minor interfacial waviness and localized coating deformation, consistent with limited electrolyte uptake and slight softening of the FBE, but no clear evidence of interfacial debonding or coating failure. It appears that the hydrogen charged sample shows the same features as the as-received and control samples, indicating no significant effect of hydrogen under the selected experimental conditions.

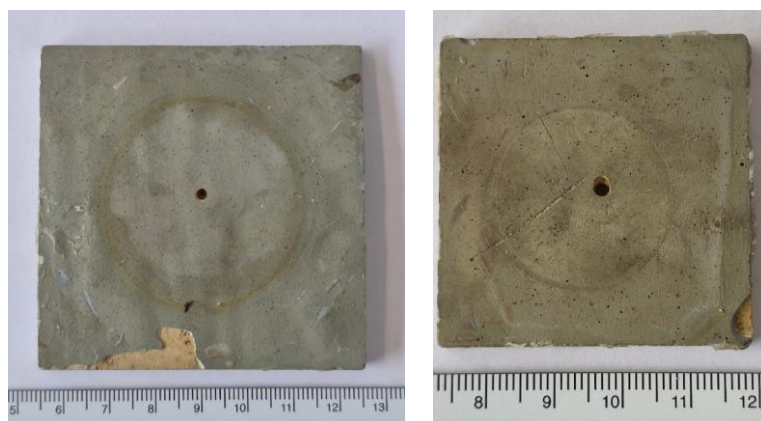
**Figure 17 – FBE with MCL Top view of samples after exposure to NS4 at room temperature. Left, FBE with MCL control sample. Right, FBE with MCL sample charged with hydrogen.**

Figure 17 shows the top view of FBE with MCL samples evaluated in this program. Both samples show peeling of the MCL outside the exposure to NS4 area which confirms a brittle nature. No signs of blistering or delamination are

observed; however, discoloration is observed in the area in contact with NS4 along with corrosion product in the defect for both the control and hydrogen charged sample. Discoloration of a multi-component liquid layer generally indicates chemical reactions, environmental degradation, phase instability, or interactions with surrounding materials. The specific cause is often system dependent and usually reflects a change in composition or structure rather than a benign aging effect, making discoloration a useful diagnostic indicator in material and coating evaluations.

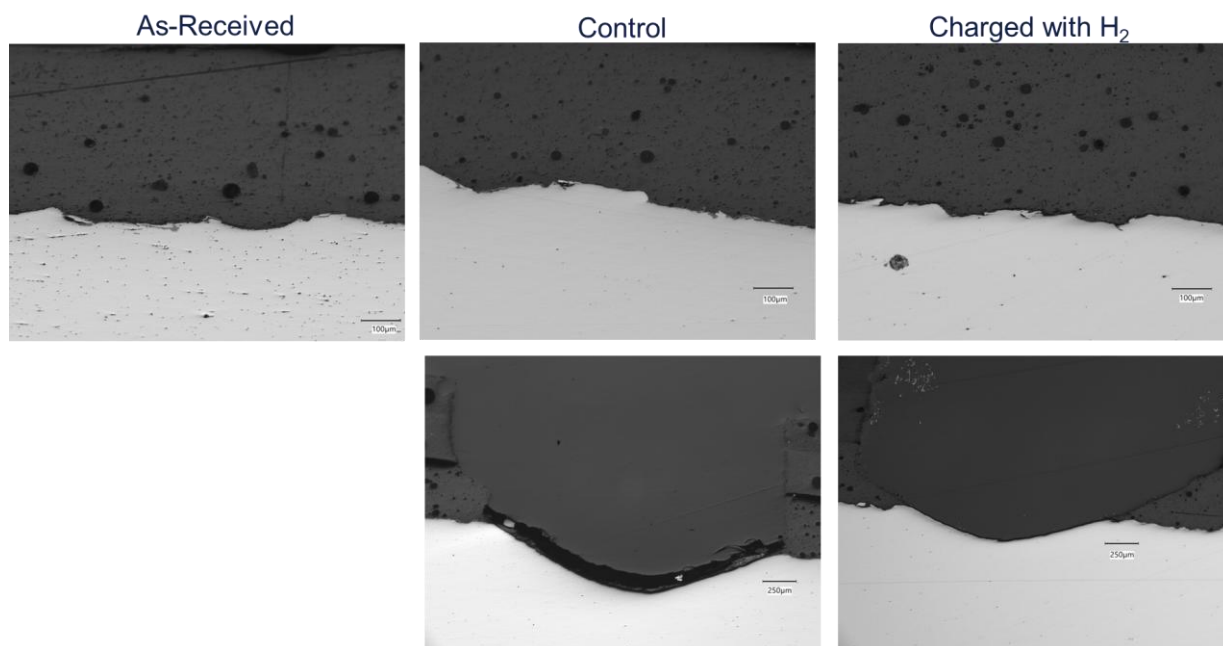
**Figure 18 – Cross section of FBE with MCL samples.**

Figure 18 shows the cross section of the FBE with MCL in the as-received, control and hydrogen charged conditions. In the as-received condition, the FBE coating appears dense and relatively uniform, with good interfacial contact to the steel substrate. The MCL layer on top of the FBE seems to be continuous, with no obvious signs of interfacial separation or extensive defect formation. Minor dark features observed within the coating are consistent with inherent porosity or fillers typical of FBE systems and do not indicate degradation. Overall, this condition represents the baseline microstructure prior to environmental or electrochemical exposure. For the control and hydrogen charged samples, the coating and MCL layer remain largely intact with no visible signs of damage around the defect. The NS4 exposure can promote limited water uptake into the FBE, leading to slight swelling or increased contrast variations within the coating. However, the interface between the steel and FBE remains continuous, and there is no clear evidence of large scale disbondment or cracking. This indicates that exposure to simulated soil solution alone may slightly influence the coating through hydration and ionic ingress rather than through severe interfacial degradation under the experimental conditions selected for this program.
