## **Project Report (Work Package 4)**

### ***Hydrogen Impact on NTS Welds***

Submitted to:  
National Gas Transmission

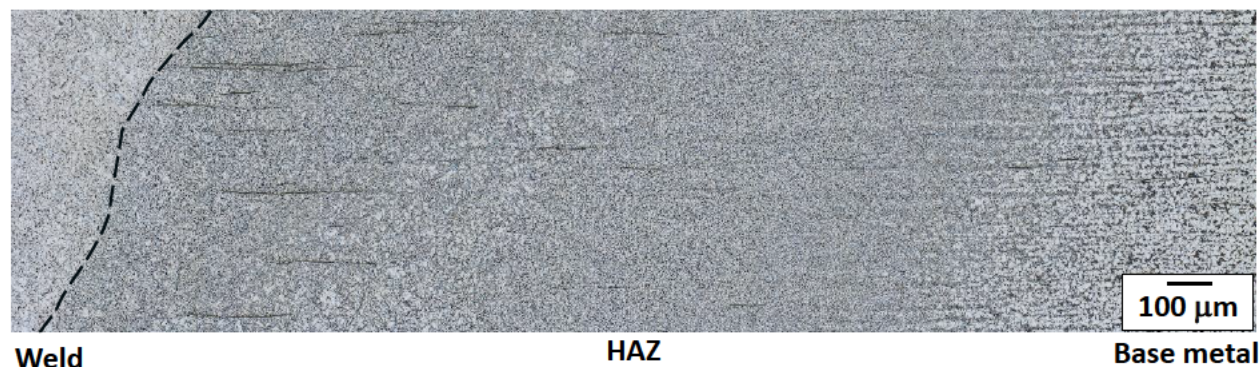
The microstructures in the weld HAZ were more complex. A typical optical micrograph of a traverse from the weld near the fusion line to the base metal is shown in Figure 2. The thermal cycles introduced during welding resulted in differences in the microstructure, with higher peak temperatures and faster cooling rates near the fusion line to temperatures which do not significantly alter the base structure about 2 mm away. In the present case, no martensite was observed in the optical microscope. It is apparent that the inclusion stringers are present even very close to the

**Figure 2:** Etched cross section showing the weld fusion line and the variability of the microstructure in the HAZ of the X60A girth weld. The horizontally aligned features in the HAZ adjacent to the weld fusion line are MnS stringers.

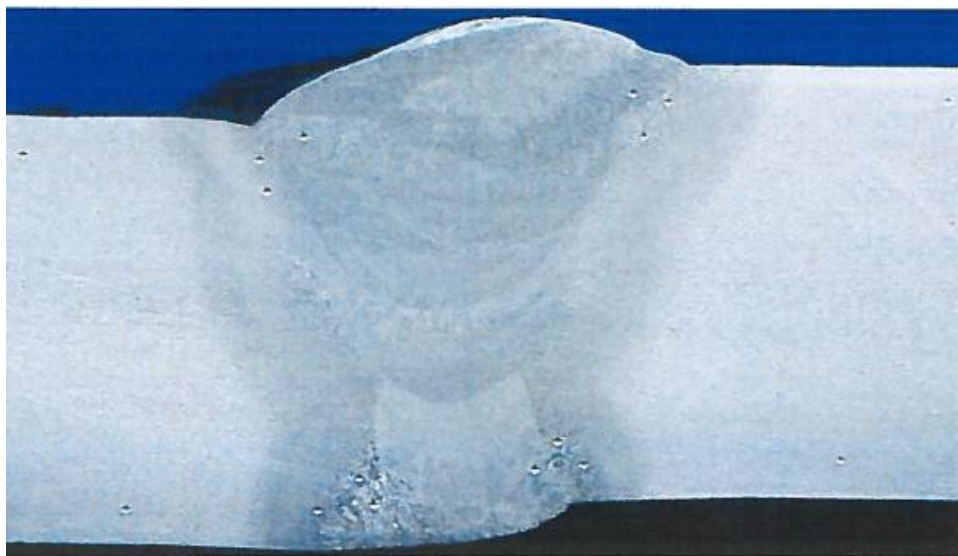
An example of less than desirable fit up taken from one of the post weld destructive examination records is shown in Figure 21.

**Figure 21.** Macrophotograph showing the appearance of weld in report MAN 212568
